BETTER SUPPORT SYSTEMS AND MECHANICAL SEALS

for Multiphase Oil and Gas Pumping in the Jungle

Bornemann Multiphase Pump MW 335

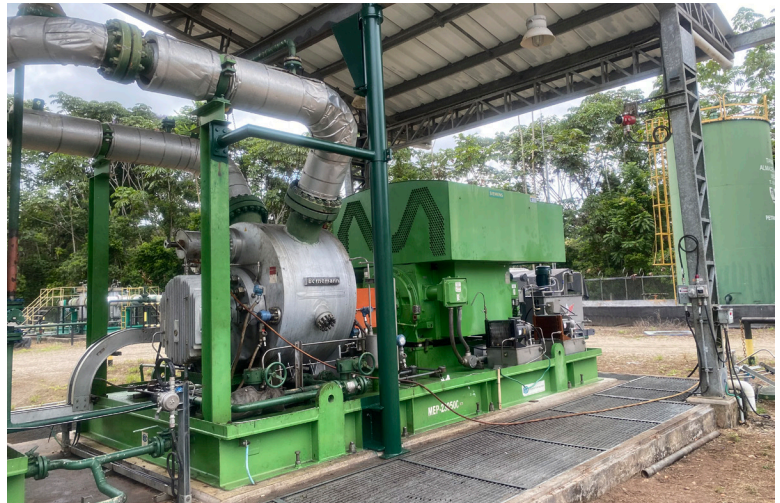
Figure 1. Complete Installation

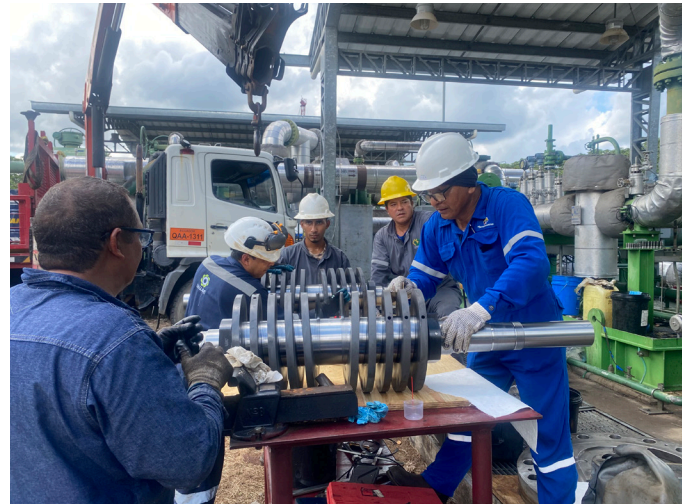
Figure 2. Field fitting rotating assembly

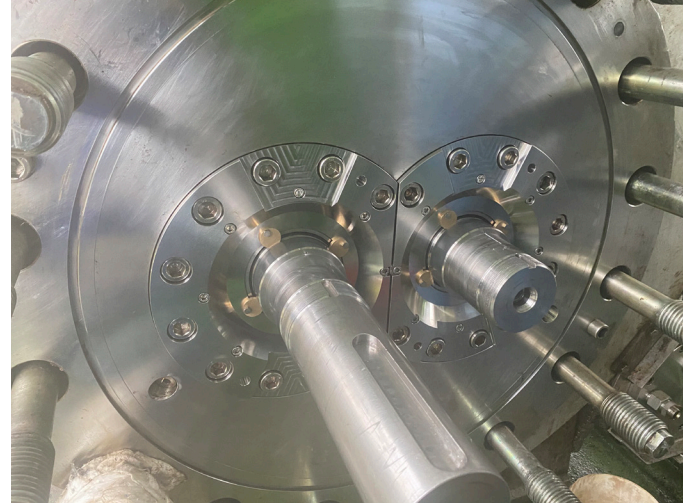
Figure 4. Upgraded Installations Ready for Service

The systems were delivered in just eight weeks and were successfully commissioned while working through the challenges of the remote Amazon location. Now more than one year into operation, the units have run continuously without failure or deviation from design parameters. Oil reservoir refills have remained consistent with Flexaseal's design expectations and operators' practices, confirming that the seals require no additional lubrication.
